# Manhole Inspection Summary

Manhole # S23C1\_016MH

**Inspection** ☐ Is Incomplete Rating: **4) Poor**

**Location** Address: **2422 Wilgry Ct.**

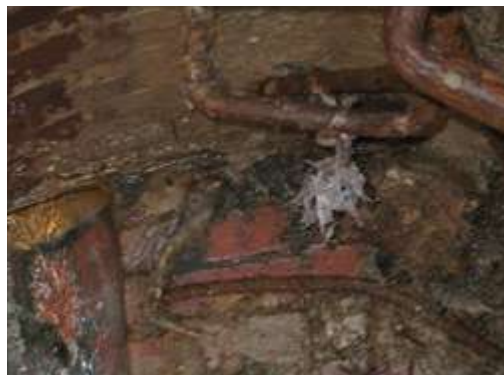
Defect 5

debris on bench and first rung, infiltration barrel

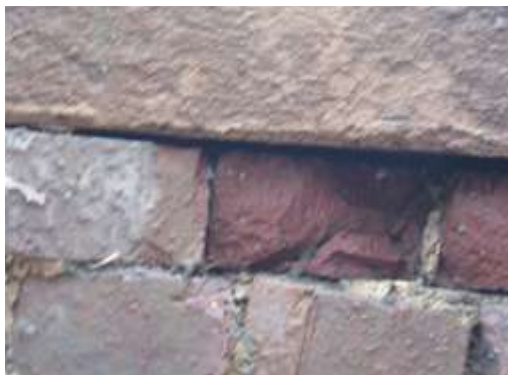
Defect 4

Condition: ☐ Sound ☐ Cracked ☐ Root Intrusion ☒ **Loose Brick** ☒ **Deteriorated**

loose brick at chimney

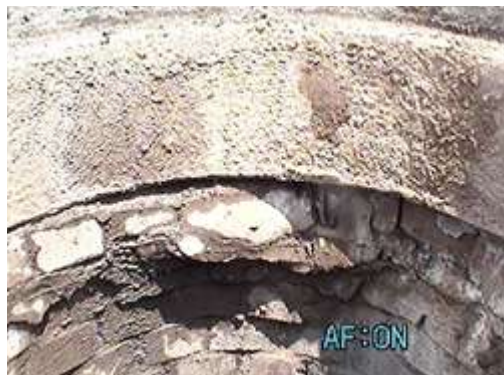
Defect 3

Condition: ☐ Sound ☐ Cracked ☒ **Leaks**

Infiltration: ☐ None ☒ **Joint** ☐ Cracks ☒ **Mortar** ☐ Roots ☐ Wall

infiltration at from lid down the frame, to the chimney and at frame and chimney joint

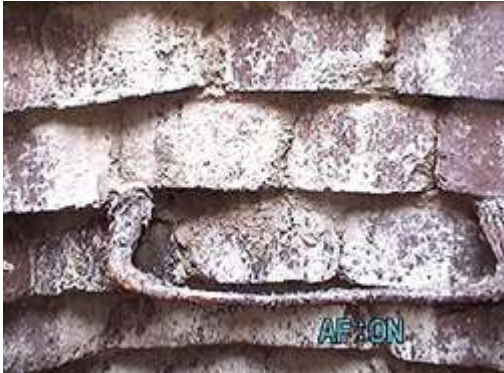
Defect 2

corbel deteriorated parged

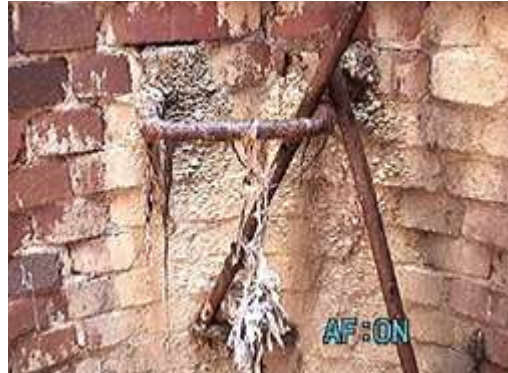
Defect 1

Count: **4** Missing: **0** ☒ **Corroded**

corroded rung

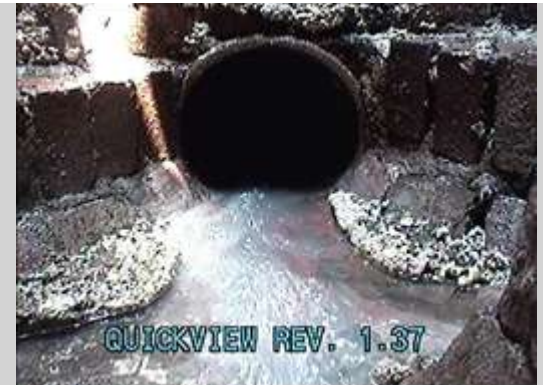
12 O'Clock Outflow

Pipe Height: **8.4** (in.) Rod and Bar (Angled)  
Pipe Material: **Clay** ☐ Pipe Lined  
Invert Depth: **8.69** (ft.) Flow Characteristics: **Fast**  
Deposits: ☒ None ☐ Mud ☐ Sludge ☐ Debris ☐ Grease  
Silt Depth: **0** (in.) Deposits Extent:  
Infiltration: **None** Pipe Seal Cond: **Sound**

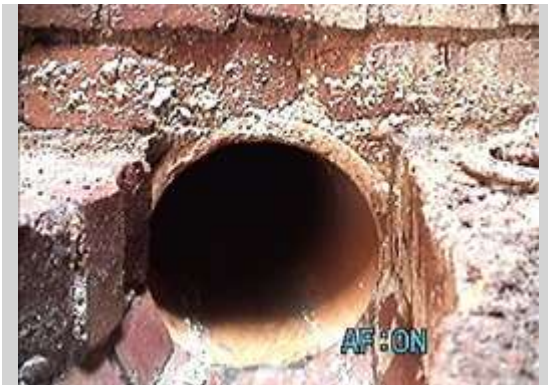
3 O'Clock Inflow

Pipe Height: **8.4** (in.) Rod and Bar (Angled)  
Pipe Material: **Clay** ☐ Pipe Lined  
Invert Depth: **8.68** (ft.) Flow Characteristics: **Fast**  
Deposits: ☒ None ☐ Mud ☐ Sludge ☐ Debris ☐ Grease  
Silt Depth: **0** (in.) Deposits Extent:  
Infiltration: **None** Pipe Seal Cond: **Sound**

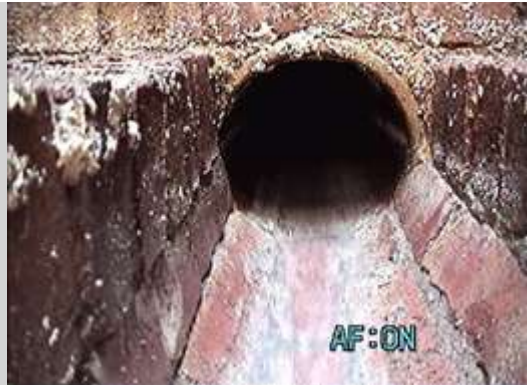
6 O'Clock Inflow

Pipe Height: **8.4** (in.) Rod and Bar (Angled)

Pipe Material: **Clay** ☐ Pipe Lined

Invert Depth: **8.69** (ft.) Flow Characteristics: **Fast**

Deposits: ☒ None ☐ Mud ☐ Sludge ☐ Debris ☐ Grease

Infiltration: **None** Pipe Seal Cond: **Sound**

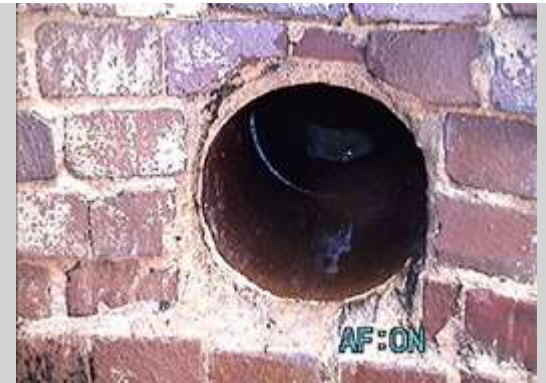
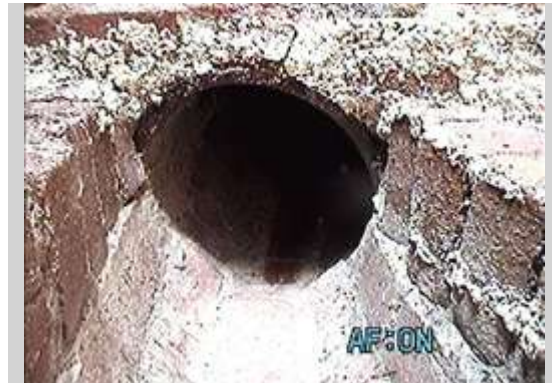
9 O'Clock Inflow

Pipe Height: **8.4** (in.) Rod and Bar (Angled)

Pipe Material: **Clay** ☐ Pipe Lined

Invert Depth: **6.21** (ft.) Flow Characteristics: **Fast**

Infiltration: **None** Pipe Seal Cond: **Sound**

| Drop: <b>Inside</b> | <b>Rod and Bar</b> |
| Angled: <b>Yes</b> | Reading: <b>7.52</b> (ft.) |
| | Inv Depth: <b>8.52</b> (ft.) |
| Drop Condition: <b>Open</b> | |
